## Re-tolling the bells - preservation of an historic bell tower

Dr MacLaren North<sup>1</sup>

**Abstract.** The Eveleigh Railway Workshops were the major locus of construction of steam locomotives in New South Wales, Australia, and the largest railway workshops in the Southern Hemisphere in their heyday. The site, located in the inner city suburb of Redfern in Sydney, operated from 1888-1988 and was then adapted into the Australian Technology Park (ATP), a commercial business park focused on innovative technology and research. A considerable amount of the preservation work on the site was, however, only half-done at the time of adaptation, and Extent Heritage spent much of the last ten years assisting the ATP management with backlog maintenance and preservation projects. One major incomplete project was the preservation of the bell tower on the former Works Managers' Office. A late 19th century rendered masonry building with later extensions, it is surmounted by a cast iron belfry with a bell that originally sounded the beginning and end of the work day at the site. Failure within the tower was causing major impacts within the building itself. Extent directed the project to cons

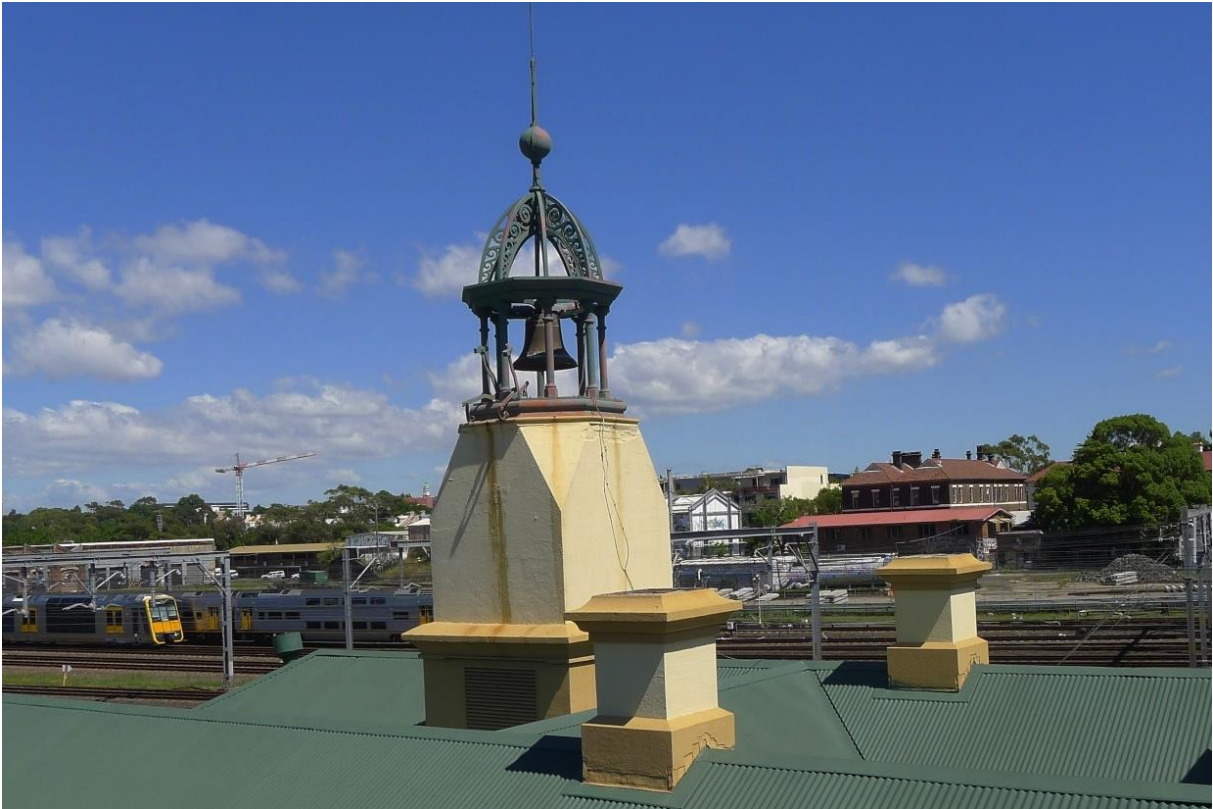
The site was initially surveyed by structural engineers and a heritage architect to determine the key elements of failure within the bell tower. This process was challenging due to the very limited access provided to the bell tower, a further challenge which required rectification to facilitate future maintenance (Fig. 2). While no fundamental structural problems were identified, there was clear evidence of water ingress to the bell tower, and a series of makeshift internal gutters which had previously been put in place were not adequate to deal with the water. Furthermore, the top of the tower was capped with a wrought iron plate which had serious issues with decay, and was causing rust jacking to areas of the masonry. Above this iron plate was the belfry itself, a cast iron openwork structure which stood a further 2 metres above the top of the tower and was bolted into the masonry. Perimeter drains through the belfry structure were inadequate and blocked, allowing water to pond within the base of the belfry. The belfry also supported the bell, in a fixed position, with a pair of iron clappers which had previously been operated by pull ropes leading through the cast iron plate and into the bell tower itself (Fig. 3).

**Figure 2.** The belfry and tower prior to conservation (The author 2014)

A rigging firm was engaged to secure the belfry to allow it to be lifted off of the bell tower via crane, in one piece, if possible. The bolts securing the structure had to be split, as most were rusted fast to the interior tie rods within the cast iron columns. After loosening of these fastenings, the crane was able to lift the belfry free of the tower in one piece, to allow it to be inspected and transported off site for conservation.

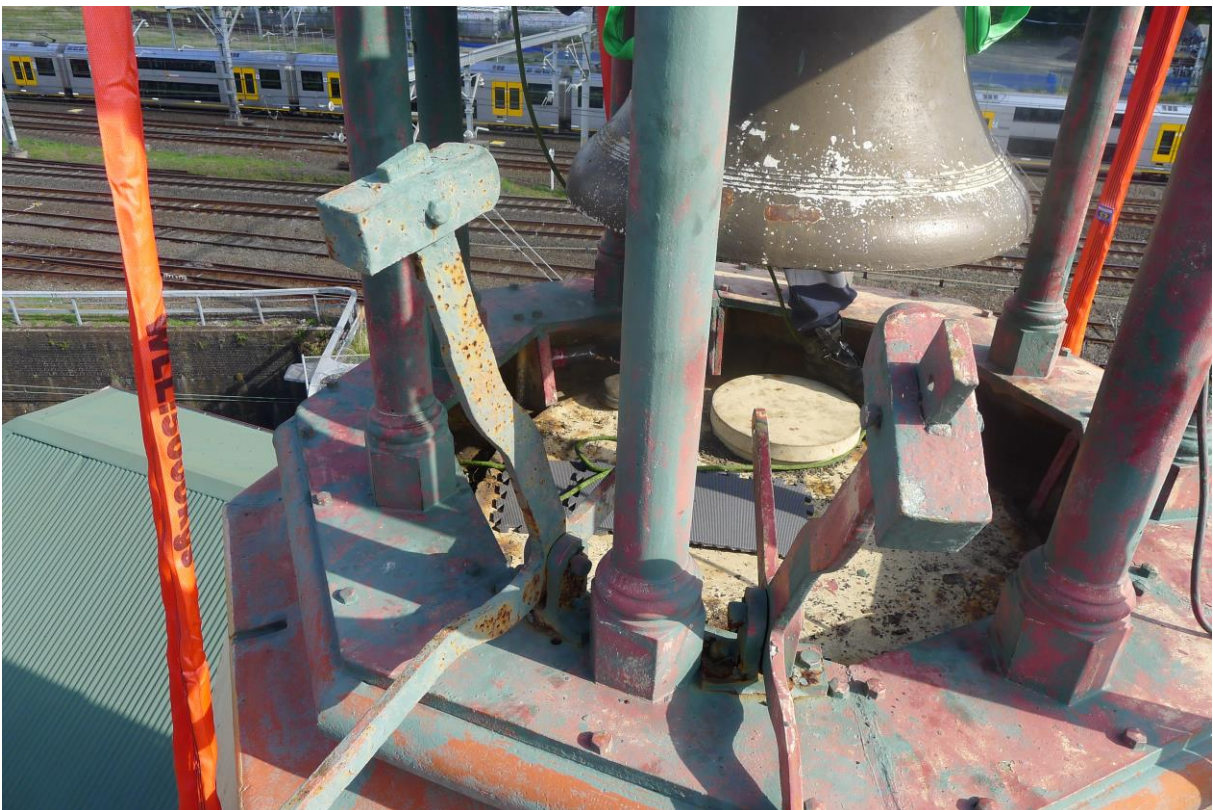
On further analysis, there was evidence the bell had been turned in the past, as the clapper marks appeared in two locations on opposite sides of the bell, and an historic photo suggested the bell had been taken down at some point in the mid-20<sup>th</sup> century. Uncommonly, the bell was of steel rather than bronze, a late 19<sup>th</sup> century innovation to supply inexpensive bells, exported from England. The bell was held in position with badly rusted mild steel hasps.

**Figure 3.** The base of the belfry, prior to removal. Note the clapper mechanism, and the circular cap was the maintenance access point. (Long Blackledge Architects 2014)

The bell required little in the way of repair, other than the replacement of the rusted fixing hasps, which were replaced in stainless steel. The paint was removed, and the bell painted to match the belfry. This was again a pragmatic decision due to the difficulty of future maintenance access, as well as the fact that the clappers (which would damage the paint) were likely to be used very infrequently. The bell was then reinstated within the repainted and reassembled belfry, ready for reinstallation.

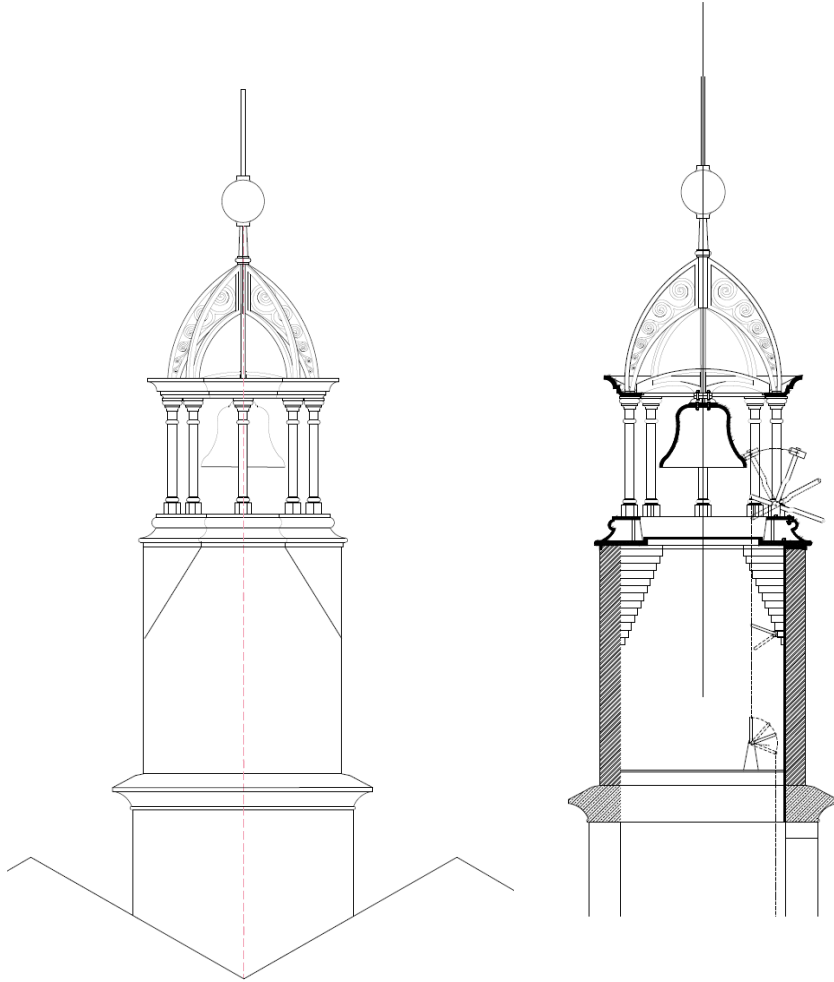
It became clear that the top of the bell tower would need to be rebuilt, with minor repairs needed to the uppermost sections of masonry and, ideally, a replacement for the wrought iron plate which provided the top of the bell

Figure 4. Elevation and cross section of the bell tower (Long Blackledge Architects 2014).

While the belfry was being treated and conserved off-site, work proceeded on the bell tower itself. The cast iron kerb around the edge of the tower was retained in situ, with the existing perimeter drains cleared and improved as far as possible, given their limited diameter. As the kerb was cast iron, re-drilling the drains to a greater diameter was deemed impractical, due to the risk of cracking the cast iron elements. The kerb was primed and repainted in situ. The wrought iron plate which served as the roof of the tower was also removed at this time, and proved to be beyond repair. The surrounding brickwork was repaired, as were the internal drains in the tower, to deal with the inevitable future water ingress. Access was also improved into the tower at this time by the insertion of stainless steel ladders internal to the tower, to facilitate safe future access. The wrought iron roof piece was ultimately replaced by a segmented stainless-steel roof piece, which was slightly conical in cross section, to facilitate the shedding of water and incorporated a new access hatch. The clapper system was rehabilitated in situ and the pull ropes replaced with braided stainless-steel cables, capped at roof level to again improve water resistance.

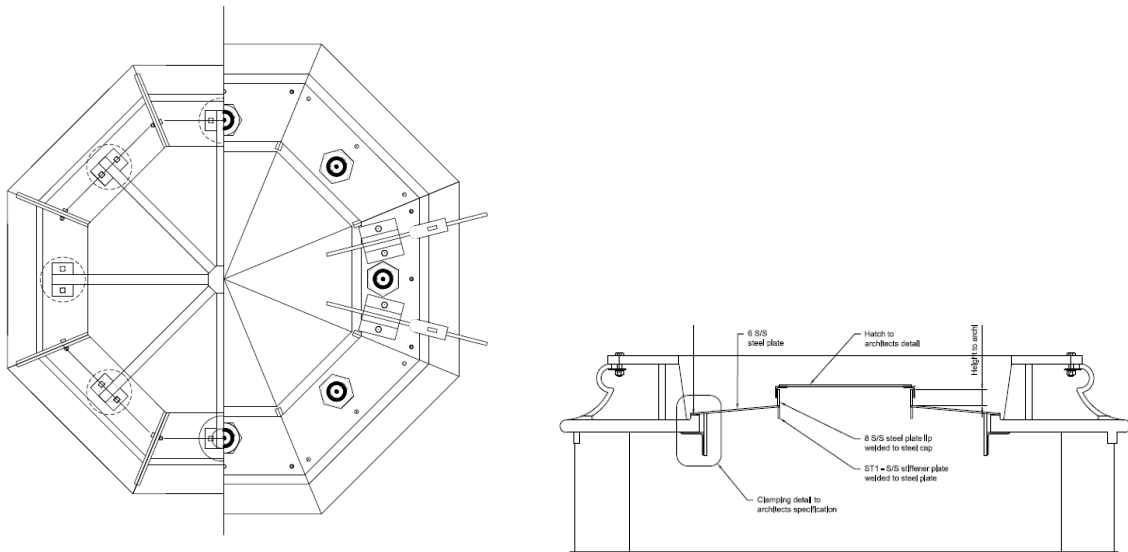
Research had identified the belfry as a relatively standard cast iron element which had been available in Australia as a catalog item, exported from England in pieces and assembled on site. The belfry is supported by 8 decorative iron columns, and it was determined that the structure was tied down to the roof via a series of iron tie rods inserted through the columns and bolted through a decorative cast iron kerb set into the roof (Figs. 4 and 5).

Figures 5 A (top) and B (bottom). Plan and cross-section of the belfry base, showing the attachment arrangement for the cast iron belfry (Long Blackledge Architects 2014).

Further minor modifications were required to the belfry to reinstate it. The structure was successfully disassembled, allowing it to be painted in a zinc rich primer and then painted with a two pac epoxy paint, which would provide the greatest longevity, again due to the difficulty with future maintenance. The cast iron tie rods within each column were however not suitable for reuse, and were replaced with stainless steel tie rods and new stainless-steel fixings. In general, where required, all fixings were replaced with stainless steel. The lightning rod atop the belfry was also repaired in copper.
