EPiC Series in Built Environment

Associated Schools of Construction Proceedings
of the 56th Annual International Conference

Evaluating the Use of Unmanned Aerial Systems (UAS) to Perform Low-Slope Roof Inspections

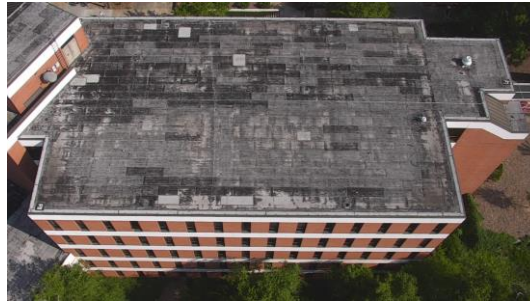
Figure 2: Subject Roof

It was important to identify a roof with sufficient defect data points for a comparison between the two inspection methods. Hence, ease of access to the roof, the age of the roof and the number of defect points on the roof were the key selection factors for this study. With this in mind, the researchers reached out to the facilities department at a public university to evaluate the various roofs installed on-campus. With the input of the roof maintenance manager and the SME roofing inspector, a low-slope roof that was installed in 1999 (20 years old) with multi-ply modified bitumen roof membrane was selected (figure 2).

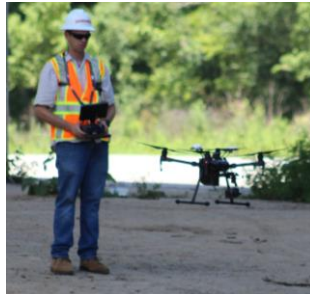
Figure 3: M210RTK and Pilot

For this experiment, two Da-Jiang Innovations (DJI) drone were used. This first was a Phantom 4 Pro (P4P) and is equipped with a 1” complementary metal-oxide semiconductor capturing, 20-megapixels sensor. The camera is mounted below a 3-axis stabilized gimbal. This aircraft was used to collect images to create the base framework of the model.. A preprogrammed flight was created using the Pix4D capture application where the drone flew approximately 50’ above the roof surface with 80% overlap between pictures. The camera was angled at 10 degrees to capture elevation changes on the roof surface. The second UAS used was DJI’s M210RTK model (figure 3). This is a general purpose aircraft that can support a variety of sensors. For this experiment, a Zenmuse Z30 camera was selected. The Z30 provides a 30x optical zoom allowing for detailed image capturing without flying near obstructions. This aircraft was used to capture images around penetrations, flashing and other areas where roof failures commonly occur. The high resolution images increased the resolution in the model at locations where building envelope failures are most common.

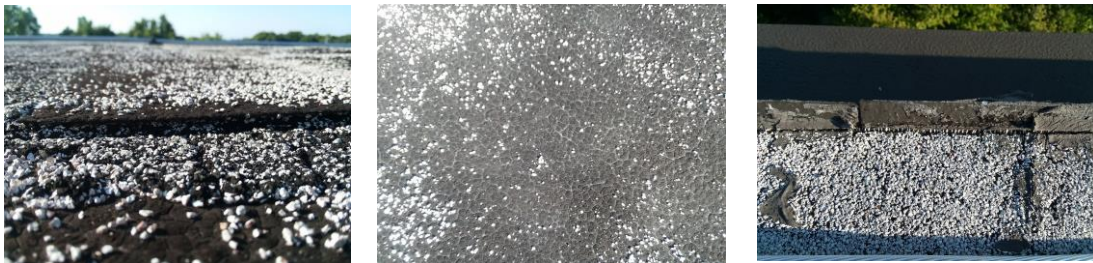
Figure 5: Examples of Defects Observed on Roof

Two days after 3D model roof inspection, the SME roof inspector conducted a traditional in-person roof assessment inspection on the same subject roof using the same inspection checklist used with the 3D model. The inspection data points were recorded immediately on the roof as the inspection was being conducted. Figure 5 provides several examples of the defects observed on the roof.

Open Lap

Alligating

Damage at the Edge
