## Re-tolling the bells - preservation of an historic bell tower

Dr MacLaren North<sup>1</sup>

**Abstract.** The Eveleigh Railway Workshops were the major locus of construction of steam locomotives in New South Wales, Australia, and the largest railway workshops in the Southern Hemisphere in their heyday. The site, located in the inner city suburb of Redfern in Sydney, operated from 1888-1988 and was then adapted into the Australian Technology Park (ATP), a commercial business park focused on innovative technology and research. A considerable amount of the preservation work on the site was, however, only half-done at the time of adaptation, and Extent Heritage spent much of the last ten years assisting the ATP management with backlog maintenance and preservation projects. One major incomplete project was the preservation of the bell tower on the former Works Managers' Office. A late 19th century rendered masonry building with later extensions, it is surmounted by a cast iron belfry with a bell that originally sounded the beginning and end of the work day at the site. Failure within the tower was causing major impacts within the building itself. Extent directed the project to cons

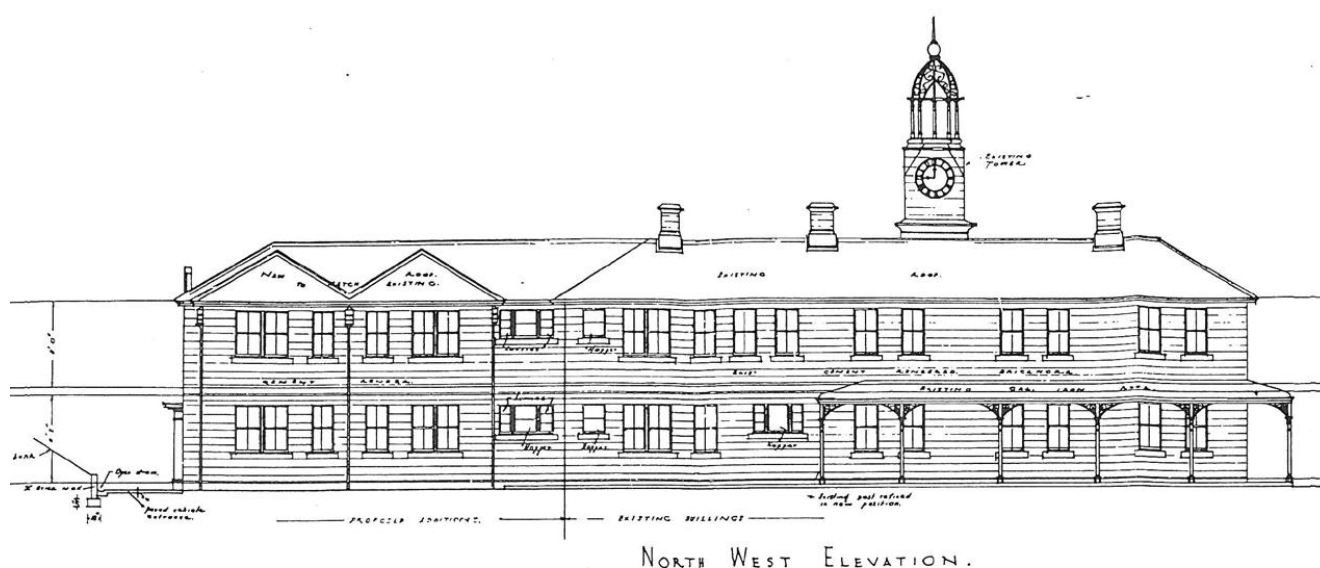
**Figure 1.** North West Elevation, 1944. : Department of Railways NSW, Ways and Works Branch. Eveleigh Works Manager's Office Additions, Plan No. 102-146, dated 23 March 1944
